Subject: Temporary Cap Inspection Summary, Campus Bay, Richmond, California
Department of Toxic Substances Control Site Investigation Order,
Docket No. 04/05-006

TEMPORARY SITE CAP INSPECTION FORM
 Campus Bay, Richmond, California

Temporary Cap Inspection Plan

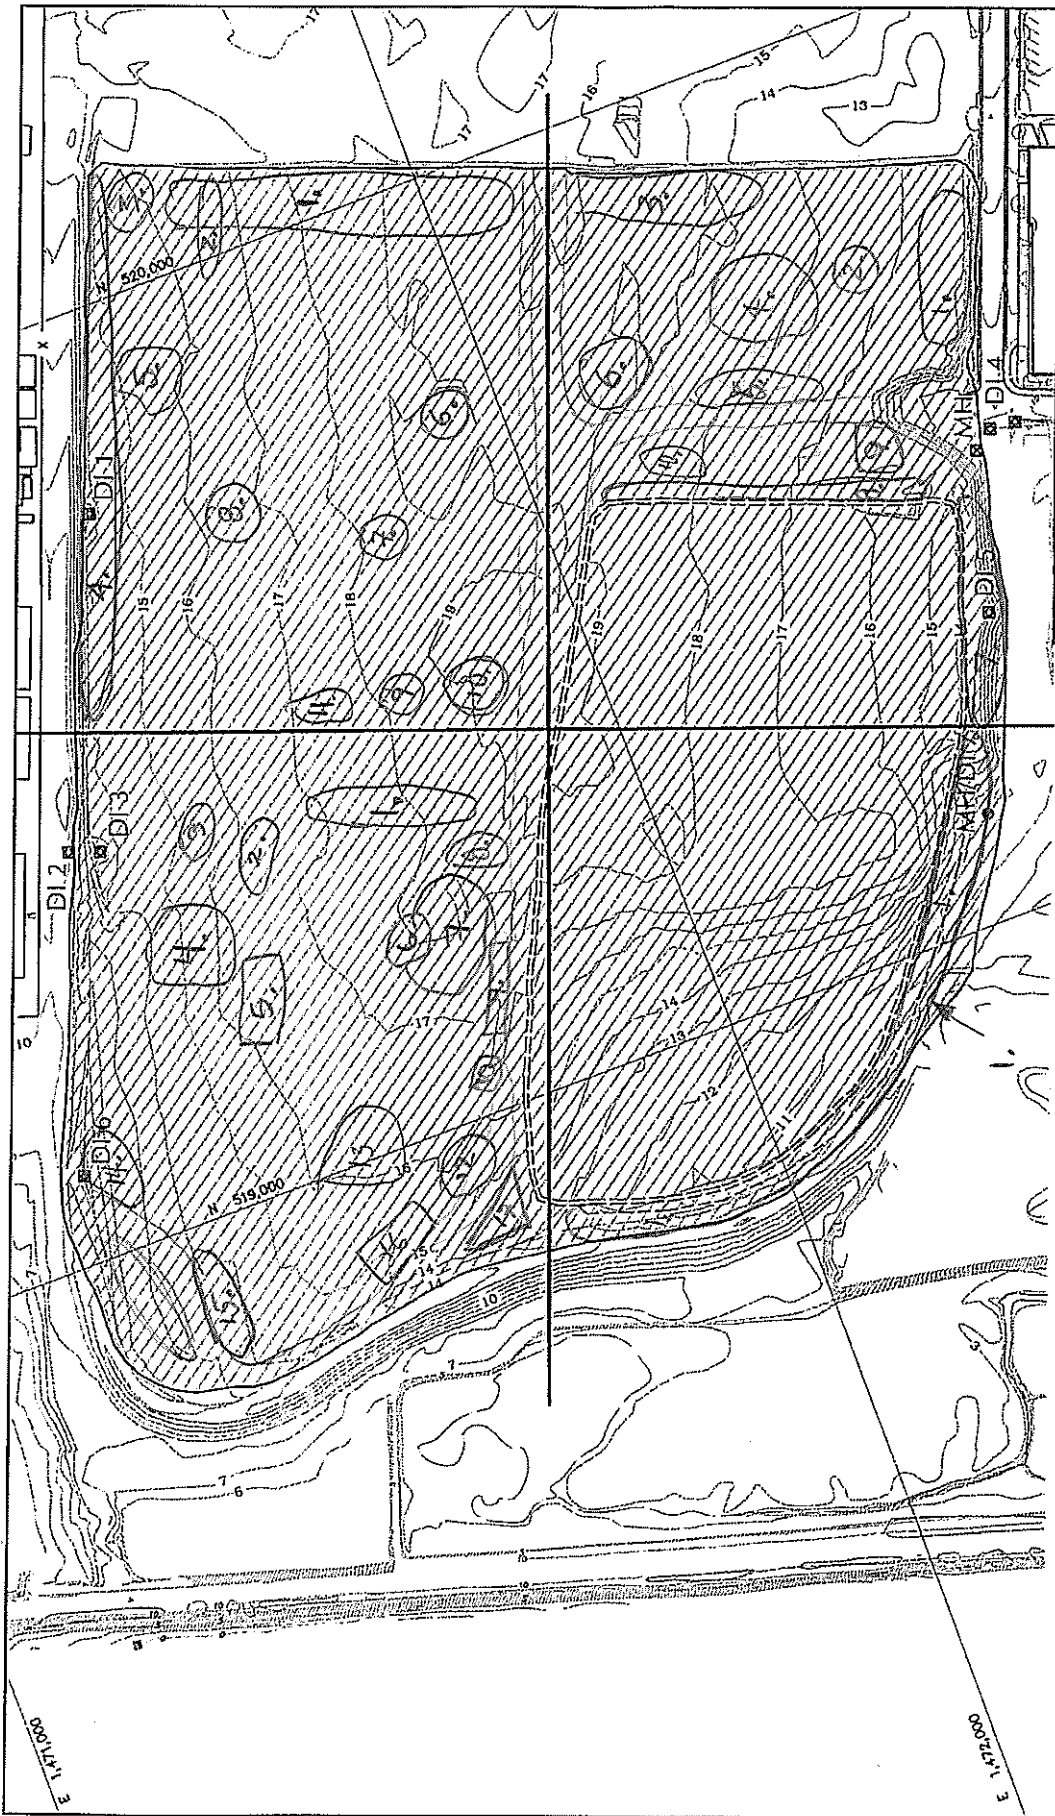
Northwest		Northeast	
Description: CRACKING <input checked="" type="checkbox"/> Yes <input type="checkbox"/> No CRACKS EXPOSED VISIBLE CINDER WHERE POSSIBLE EROSION & WORSENING EXPOSURE COULD OCCUR THROUGHOUT NW. MARK ID # 1, 2, 3, 5, 8, 9, 10, 11	Description: CRACKING <input checked="" type="checkbox"/> Yes <input type="checkbox"/> No EXPOSED CINDER BY CRACKS MARK ID # 3, 4, 5, 6		
Description: SETTLEMENT <input type="checkbox"/> Yes <input checked="" type="checkbox"/> No	Description: SETTLEMENT <input type="checkbox"/> Yes <input checked="" type="checkbox"/> No		
Description: SURFACE EROSION <input type="checkbox"/> Yes <input checked="" type="checkbox"/> No	Description: SURFACE EROSION <input type="checkbox"/> Yes <input checked="" type="checkbox"/> No		
Description: SURFACE DISTURBANCE <input checked="" type="checkbox"/> Yes <input type="checkbox"/> No VEGETATION PROTRUSION ALONG WESTERN EDGE, RUTS CAUSED BY MARK ID # 1, 4, 6, 7 VEHICLES	Description: SURFACE DISTURBANCE <input type="checkbox"/> Yes <input type="checkbox"/> No RUTS CAUSED BY VEHICLES 2, 4 VEGETATION, DAMAGE MARK ID # 1, 2, 3, 10, 9

Southwest		Southeast	
Description: CRACKING <input checked="" type="checkbox"/> Yes <input type="checkbox"/> No CRACK EXPOSING CINDER MARK ID # 1, 2, 3, 4, 5, 6, 7, 8, 9, 10, 12, 13	Description: CRACKING <input type="checkbox"/> Yes <input type="checkbox"/> No SE EDGE - (ALL), MARK ID # 1		
Description: SETTLEMENT <input type="checkbox"/> Yes <input checked="" type="checkbox"/> No	Description: SETTLEMENT <input type="checkbox"/> Yes <input checked="" type="checkbox"/> No		
Description: SURFACE EROSION <input type="checkbox"/> Yes <input checked="" type="checkbox"/> No	Description: SURFACE EROSION <input type="checkbox"/> Yes <input checked="" type="checkbox"/> No		
Description: SURFACE DISTURBANCE <input checked="" type="checkbox"/> Yes <input type="checkbox"/> No VEGETATION & RUTS/DAMAGE MARK ID # 11, 14, 15, 16, 17	Description: SURFACE DISTURBANCE <input checked="" type="checkbox"/> Yes <input type="checkbox"/> No - SEDIMENT CONTAINMENT AREA -

- apply cap material to the exposed cinder in and around the sediment containment area.
- repair any cracks and damage that visually expose cinder

- cut and remove any vegetation growth protruding the cap
